# CHISANA

## HISTORIC STRUCTURE REPORT

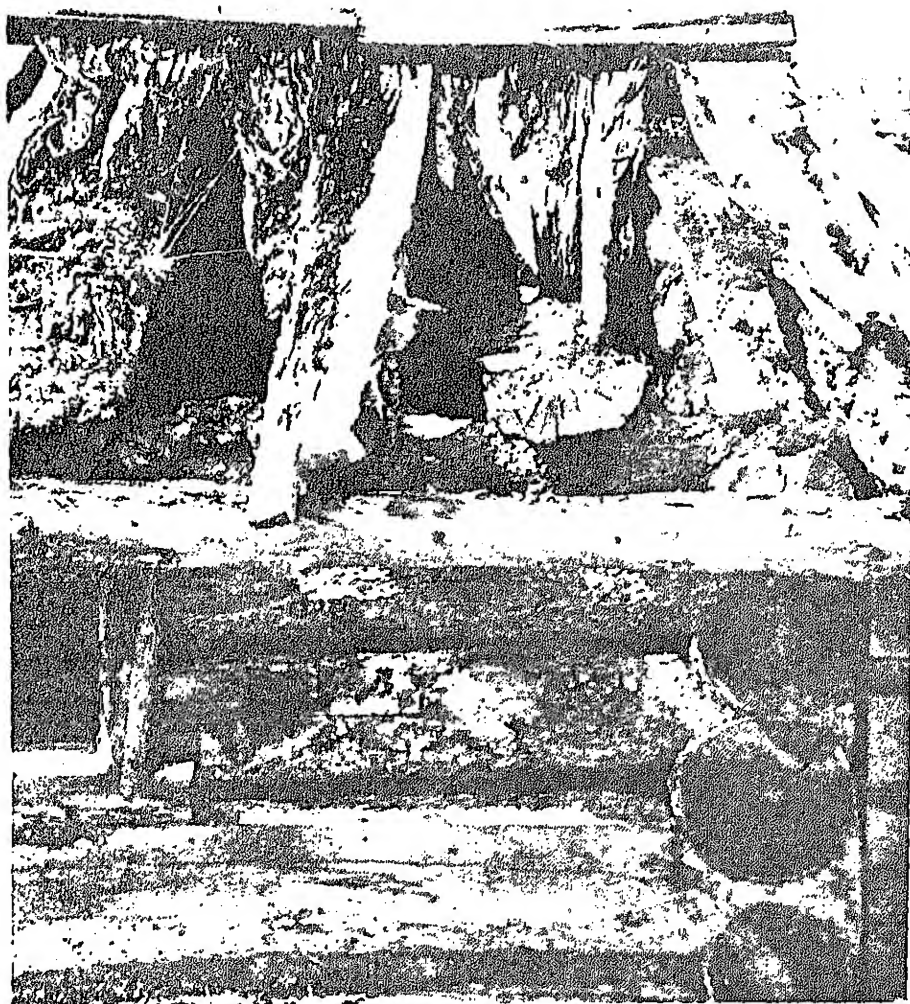
Photograph 6  
Women's Jail, Chisana  
"Hole-in-Roof" Detail, South Side.

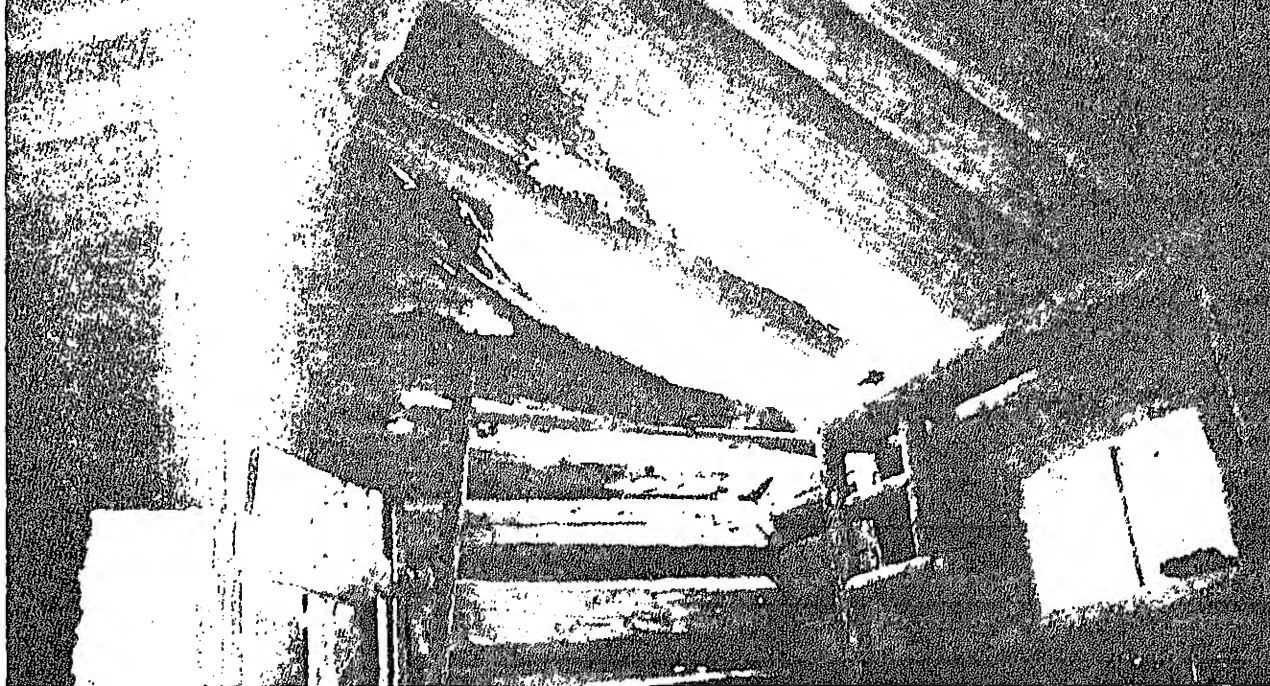
Photograph 7  
Women's Jail, Chisana  
Collapsed Ceiling, South Side.

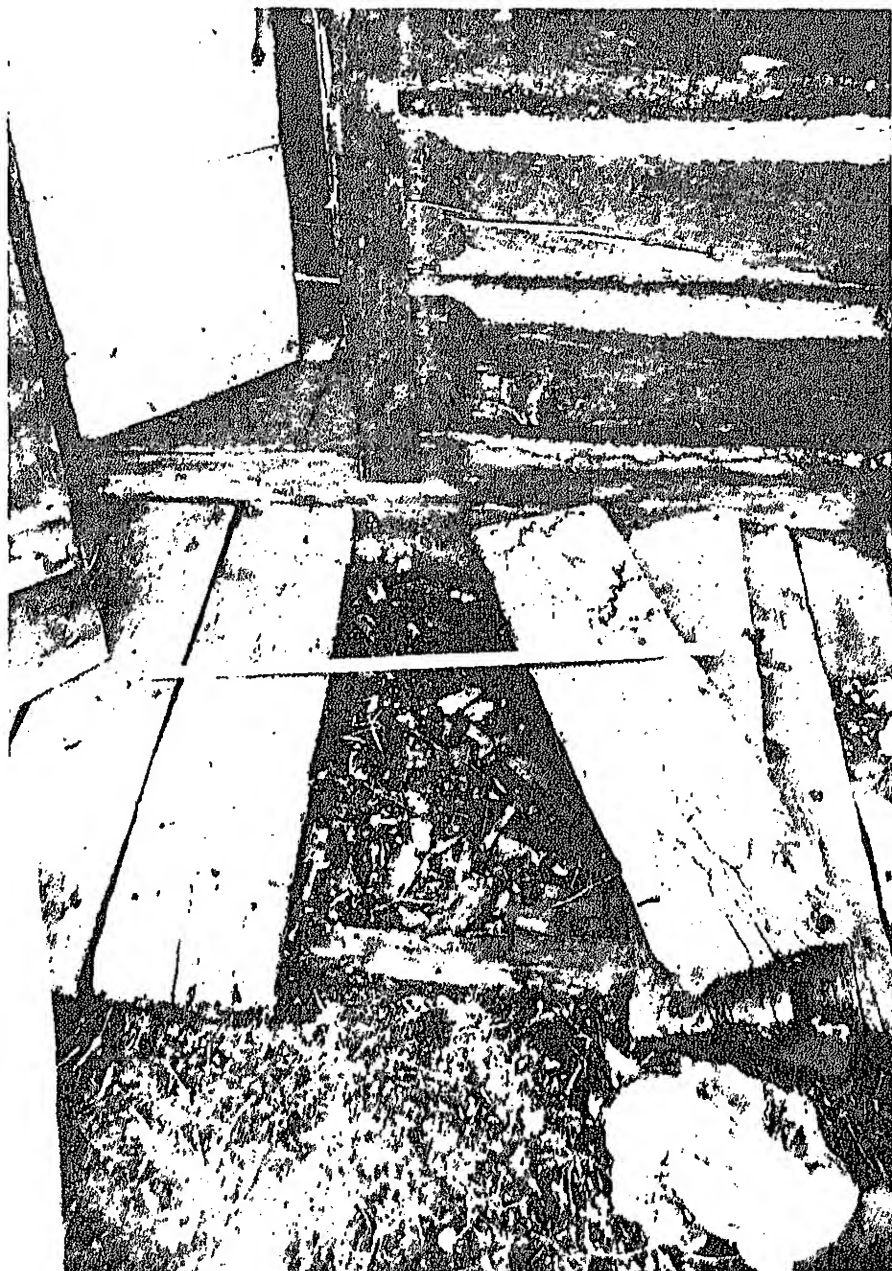
Photograph 13  
Women's Jail, Chisana  
Floor planks, porch.

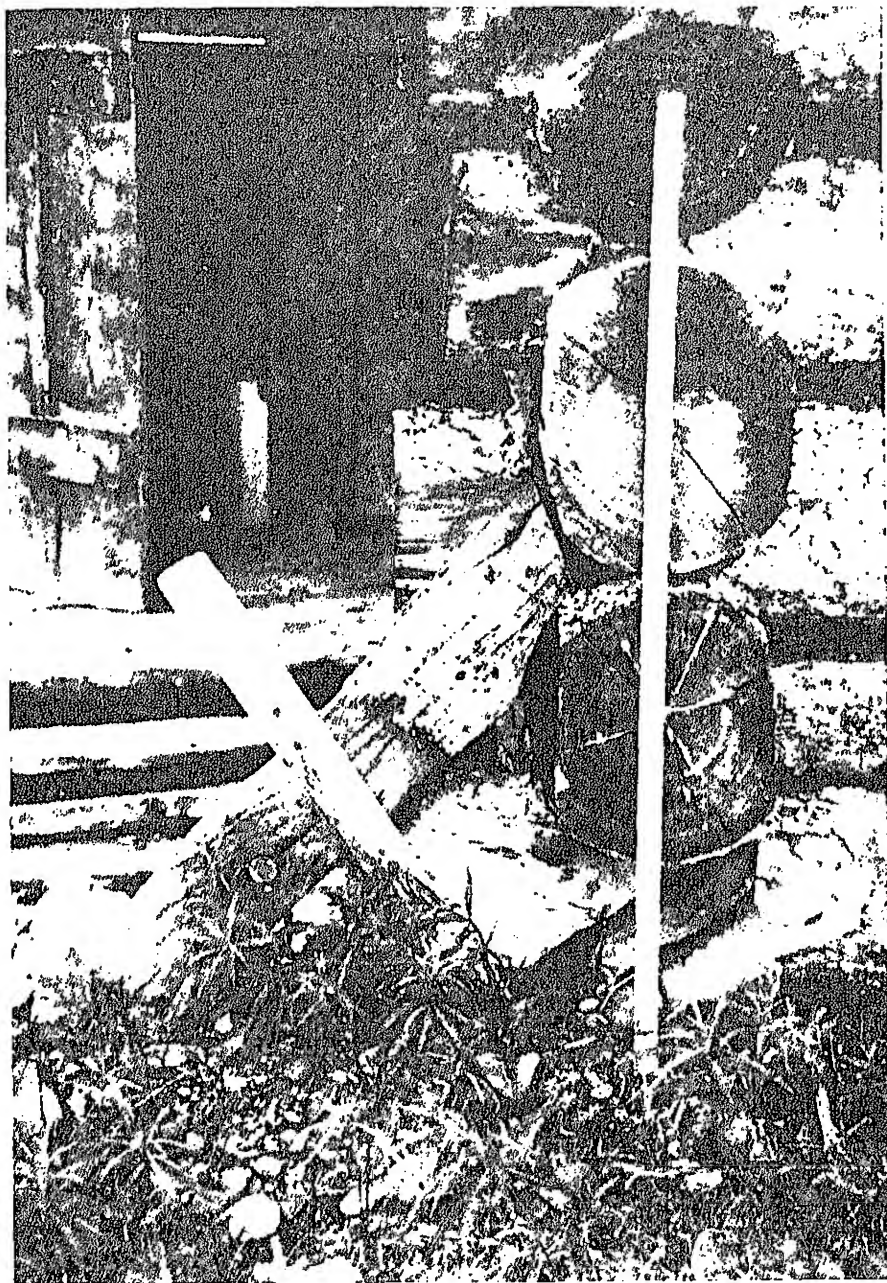
Photograph 14  
Women's Jail, Chisana  
Corner bracing at sill logs.

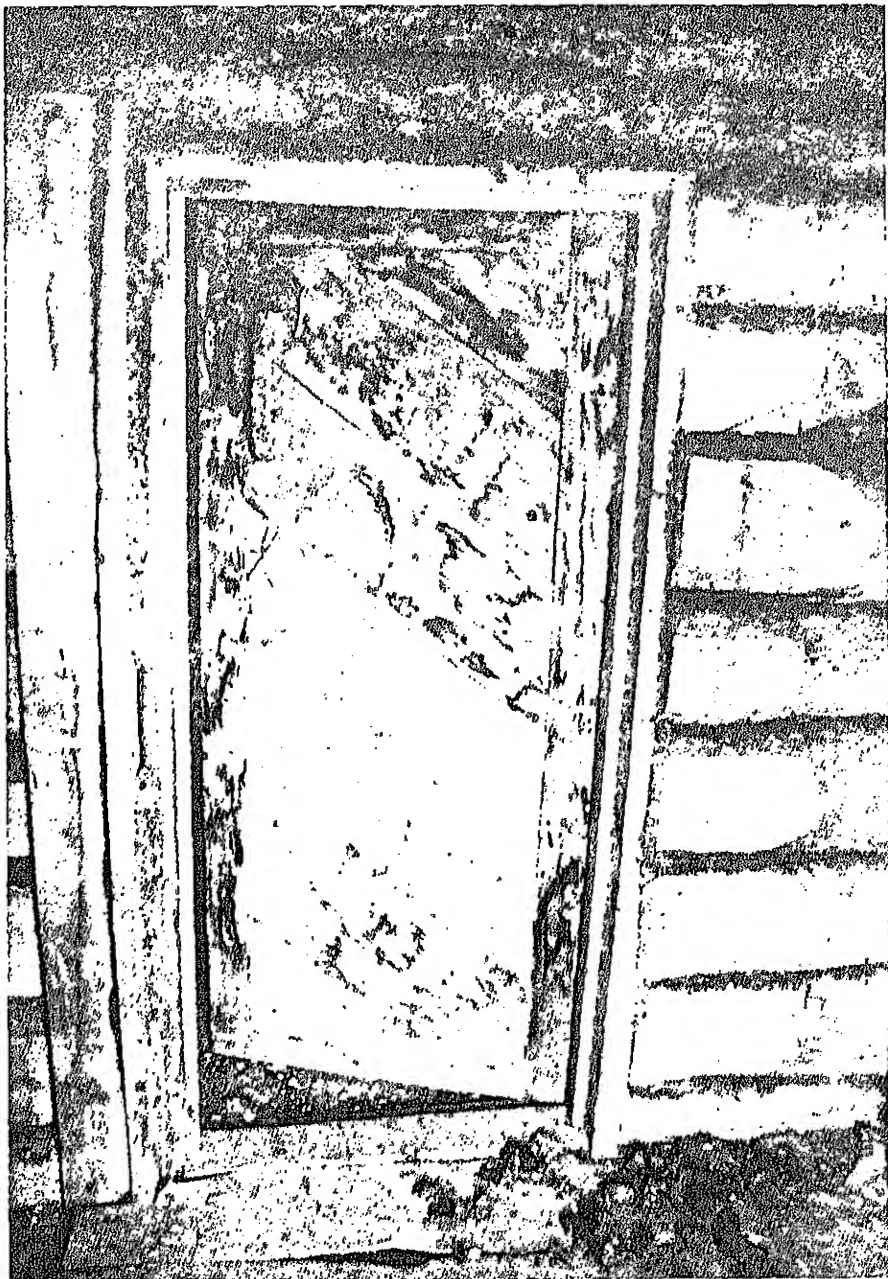
Photograph 23

U.S. Commissioner's Court, Chisana  
Front entry to main cabin with hewn  
logs at trim; trim missing on  
right side.

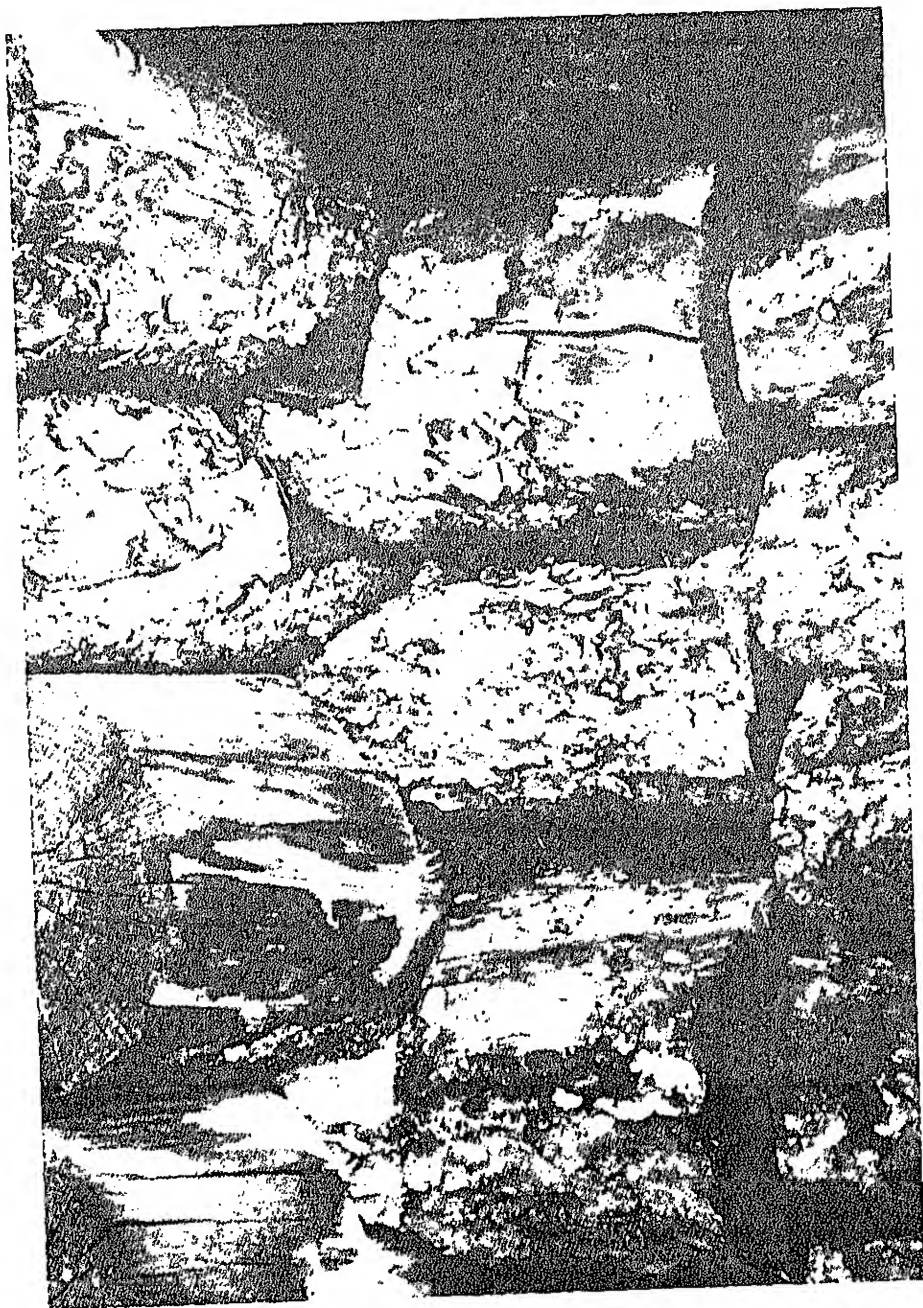
Photograph 24  
U.S. Commissioner's Court, Chisana  
Junction of main cabin logs and  
porch logs (spline just visible  
between second and third porch logs  
on right)

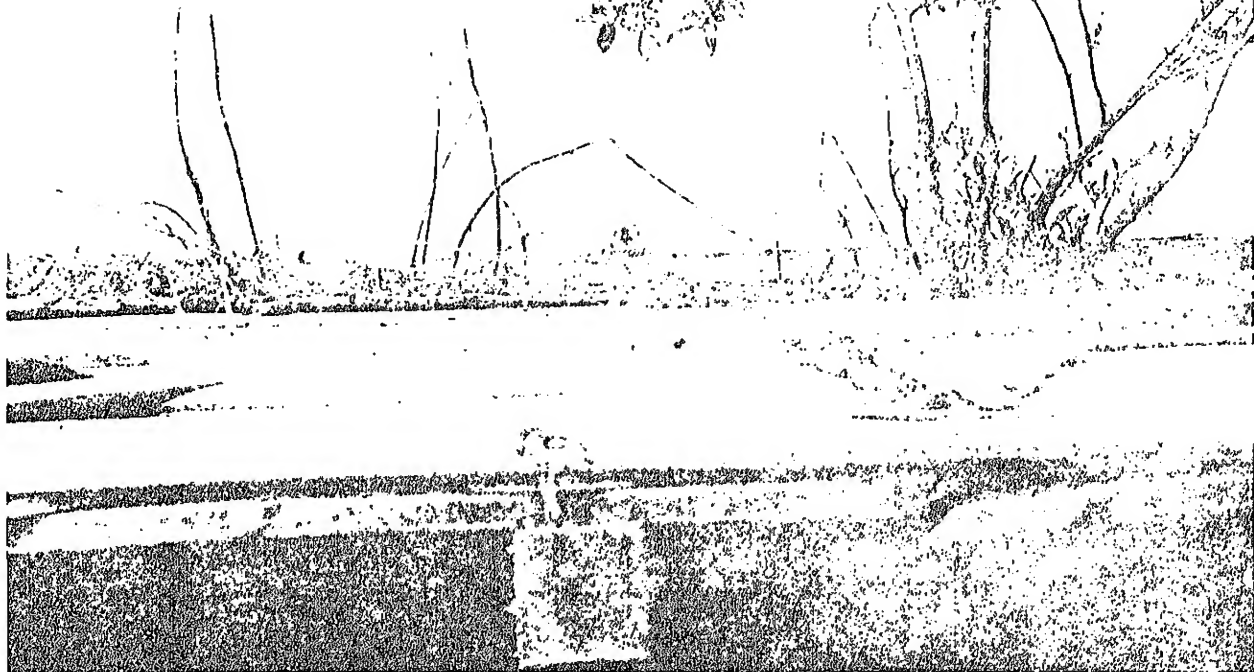
Photograph 34  
U.S. Commissioner's Residence, Chisana  
Roof detail with vegetation and  
present occupant.

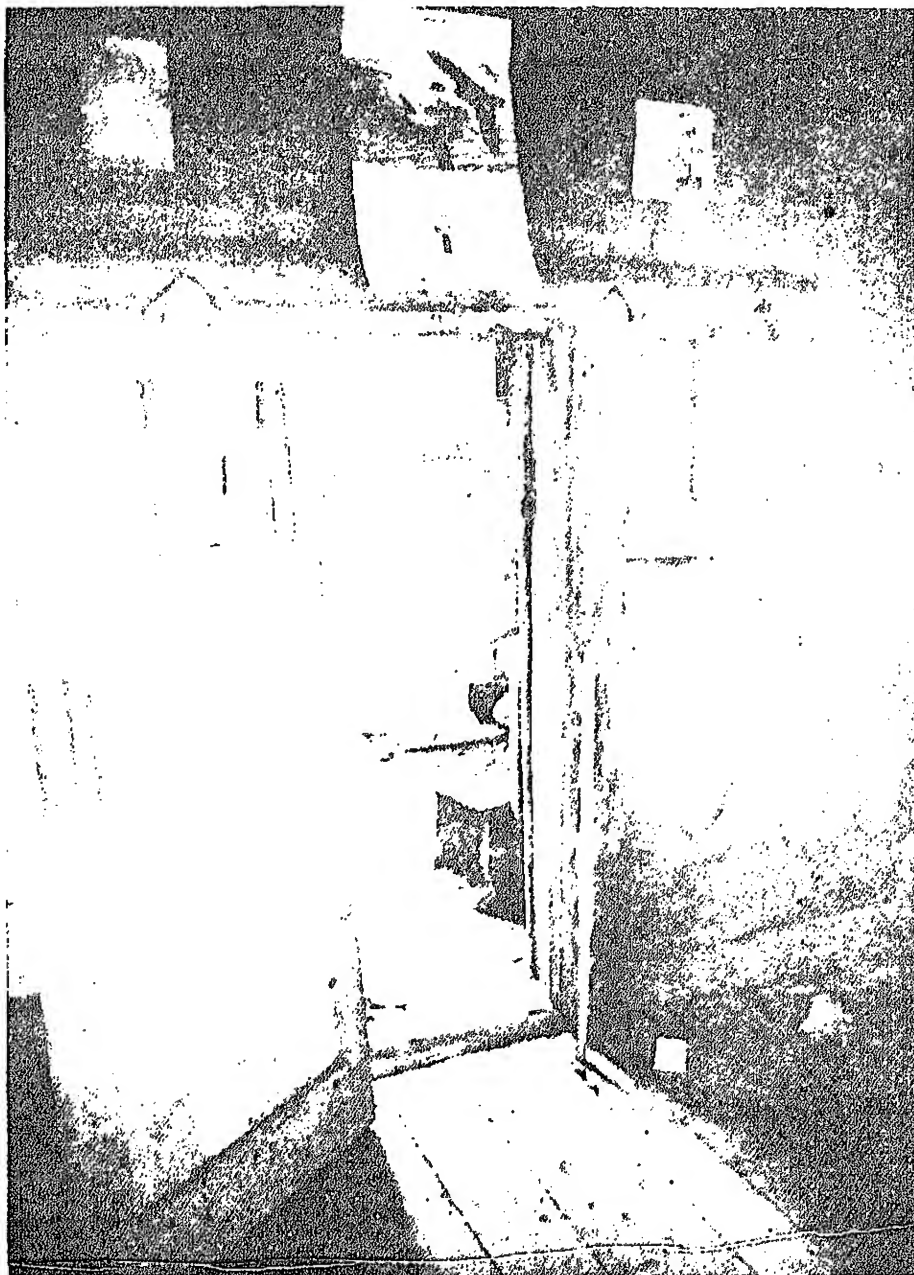
Photograph 39

Interior of entry to main cabin - note  
water stained burlap and seperating wind  
trim.

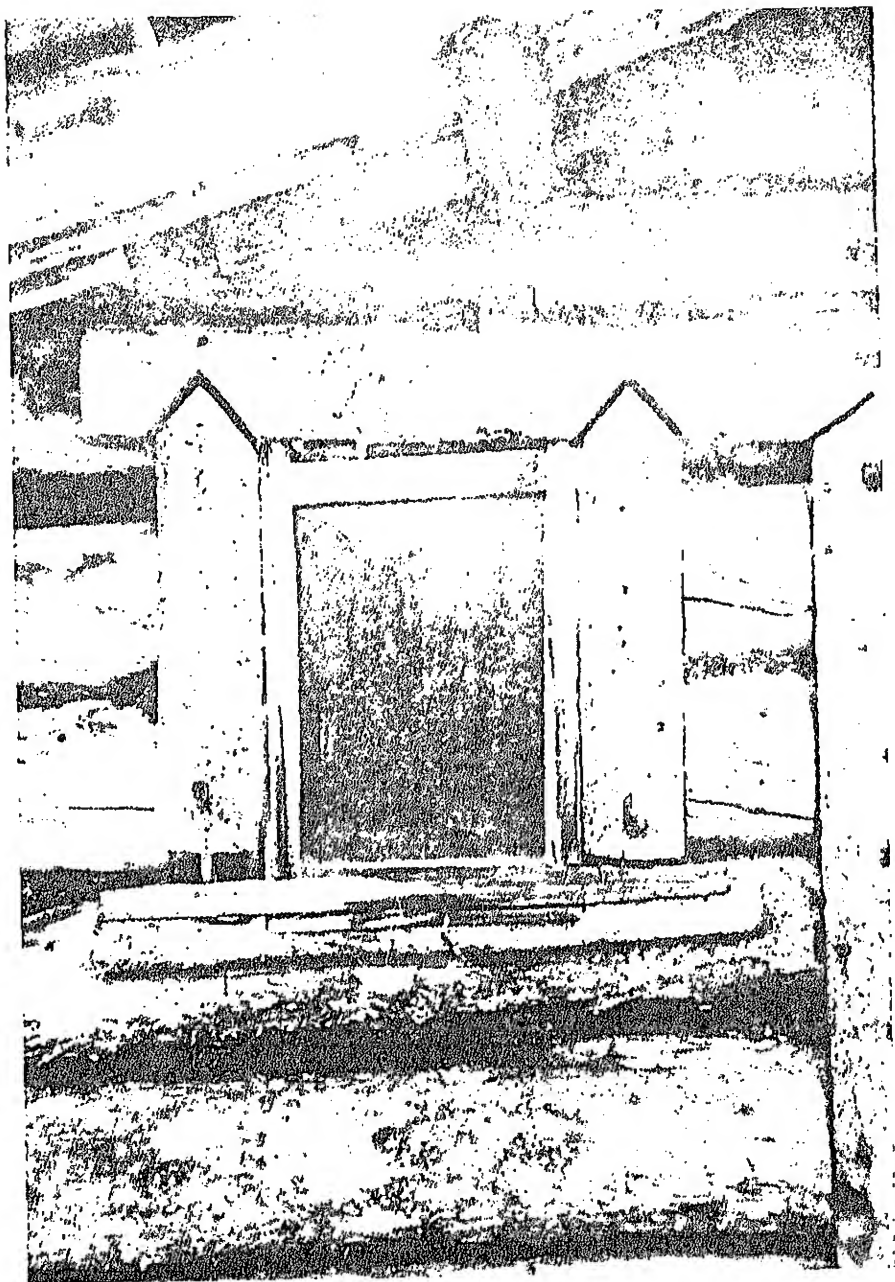
Photograph 42

Front window with racked frame and  
seperating trim (note pegs nolding trim  
in place).
